**BUILDING
MATERIALS
AND
STRUCTURES**
REPORT BMS37

Structural Properties of
"Palisade Homes" Constructions
for Walls, Partitions, and Floors
Sponsored by Palisade Homes

NATIONAL
BUREAU OF STANDARDS

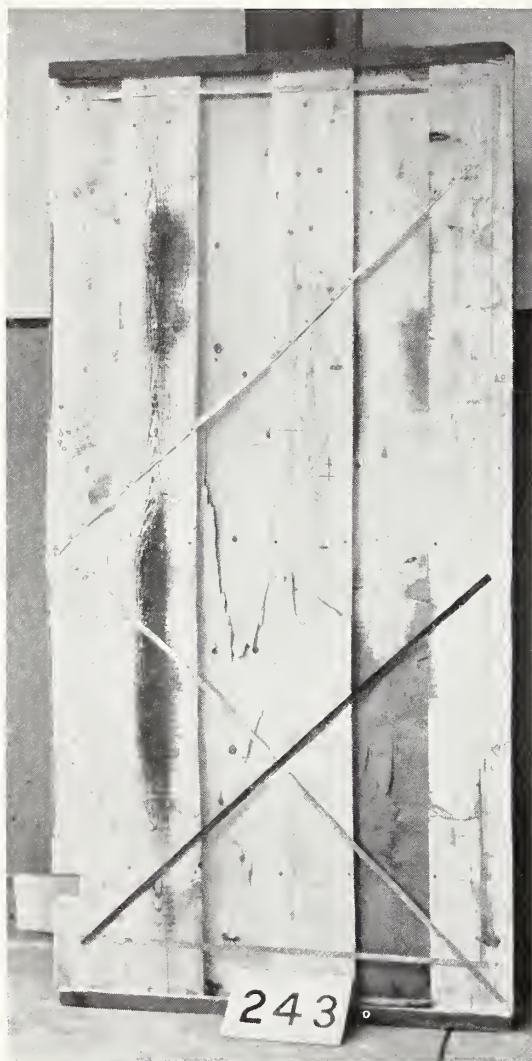
FIGURE 1.—Wall CB.

Typical specimen, except that many of the specimens did not show "skip dressing" (dark areas).

After each specimen was tested one face was removed to expose the structural members and photographs were taken to show the knots and failures. The character of the framing is indicated by figures 1 to 4.

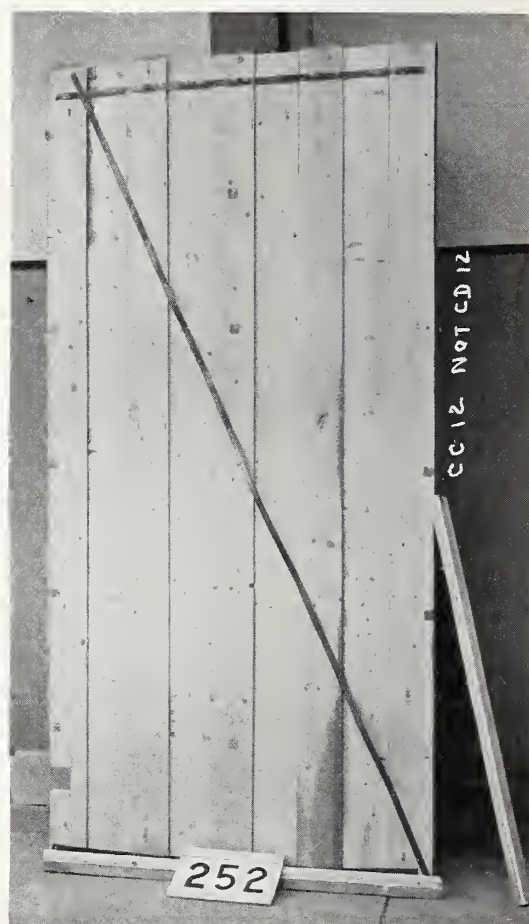
FIGURE 2.—Plank partition CC.

Typical specimen.

from a lower to an upper corner, as shown in figure 2. The strapping was fastened to each projecting plank by two nails—either 3d lath nails or $\frac{7}{8}$ -in. or 1-in. roofing nails. After assembling the planks, the upper and lower ends of the assembled unit were grooved $\frac{1}{8}$ by $\frac{1}{2}$ in. at midthickness.

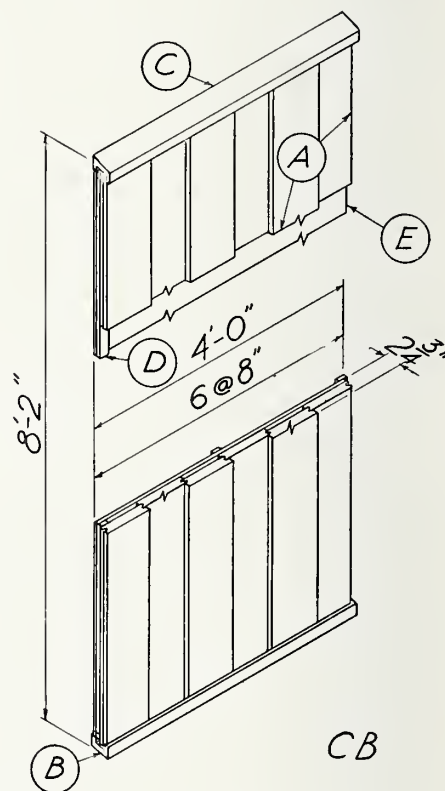
FIGURE 5.—Four-foot wall specimen *CB*.

A, planks; *B*, floor plate; *C*, top plate; *D*, filler strip; *E*, plywood wallboard.

(1) *Four-foot wall specimens*.—The 4-ft wall specimens were 8 ft 2 in. high, 4 ft 0 in. wide, and 2¾ in. thick. Each specimen consisted of six specially edge-matched planks, *A*, as shown in figure 5, so assembled that alternate planks projected ¼ in. from the adjacent planks. The planks were fastened to a grooved floor plate, *B*, and a grooved top plate, *C*, by nails.

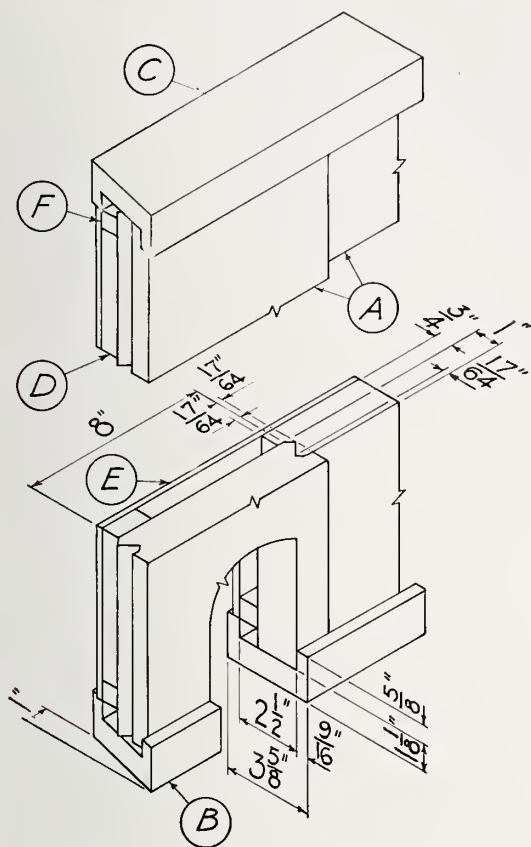
FIGURE 6.—Details of wall specimen CB.

A, planks; *B*, floor plate; *C*, top plate; *D*, filler strip; *E*, plywood wallboard; *F*, filler strip.

The outer surface of the planks formed the outside face of the wall. The inside face of the wall was plywood wallboard, *E*, shown in

figure 6, nailed to the planks and to vertical filler strips, *D*, and to horizontal filler strips, *F*.

Planks.—The planks, *A*, were eastern spruce, $1\frac{3}{4}$ by $8\frac{1}{2}$ in. (nominal 2 by 9 in), 7 ft $11\frac{3}{4}$ in. long. The planks matched as shown in figure 6, resulting in a wall surface with every alternate plank projecting $\frac{3}{4}$ in. outward from adjacent planks. After assembly the planks were held by box strapping on the inside face, as shown in figure 1. The strapping intended for each specimen consisted of two horizontal pieces, one near the bottom, the other near the top; and of four diagonal pieces, two across the lower half and two across the upper half of the

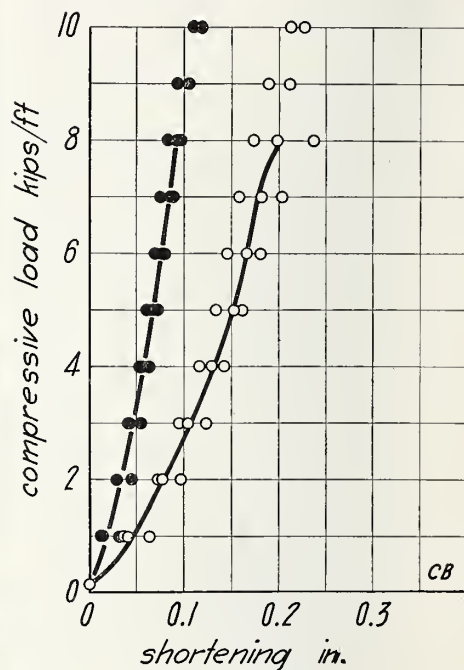
FIGURE 8.—Compressive load on wall *CB*.

Load-shortening (open circles) and load-set (solid circles) results for specimens *CB-C1*, *C2*, and *C3*. The load was applied one-third the thickness (0.83 in.) from the inside surface of the planks. The loads are in kips per foot of actual width of specimen.

Wall specimen *CB-C1* under compressive load is shown in figure 7. The results for wall specimens *CB-C1*, *C2*, and *C3* are shown in table 4 and in figures 8 and 9.

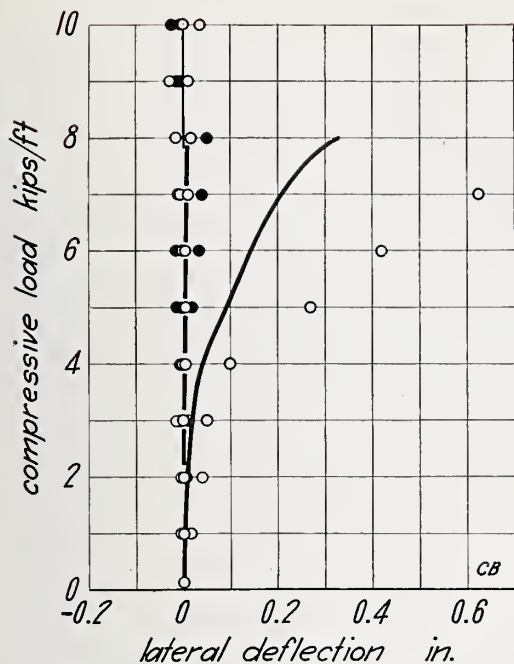
FIGURE 9.—Compressive load on wall CB.

Load-lateral deflection (open circles) and load-lateral set (solid circles) results for specimens CB-C1, C2, and C3. The load was applied one-third the thickness (0.83 in.) from the inside surface of the planks. The loads are in kips per foot of actual width of specimen. The deflections and sets are for a gage length of 7 ft 10 in., the gage length of the deflectometers.

The lateral deflections shown in figure 9 were plotted to the right of the vertical axis for deflections of the specimen toward the outside face (positive deflection) and to the left for deflections toward the inside face (negative deflection).

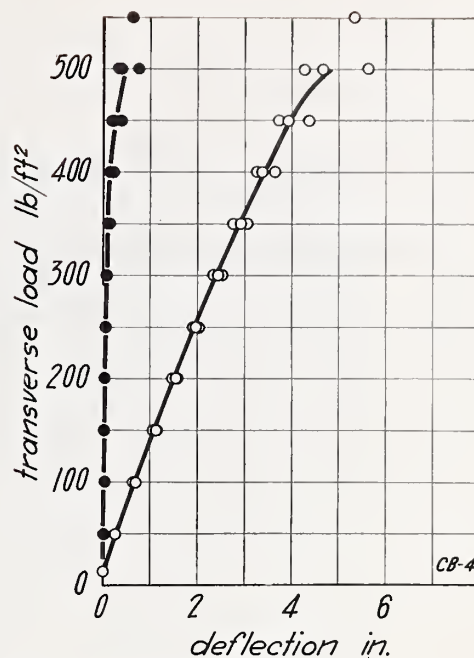
FIGURE 11.—Transverse load on wall CB, load applied to outside face.

Load-deflection (open circles) and load-set (solid circles) results for specimens CB-T4, T5, and T6 on the span 7 ft 6 in.

The results under transverse load are shown in table 4 and in figure 10 for wall specimens *CB-T1*, *T2*, and *T3*, loaded on the inside face, and in figure 11 for wall specimens *CB-T4*, *T5*, and *T6*, loaded on the outside face.

At the maximum loads specimens *T4*, *T5*, and *T6* failed by rupture of all or all but one of the planks at or between the loading rollers. The plywood wallboard was undamaged but separated from the planks at the ruptures and at the ends of the specimens by pulling the nails from the planks.

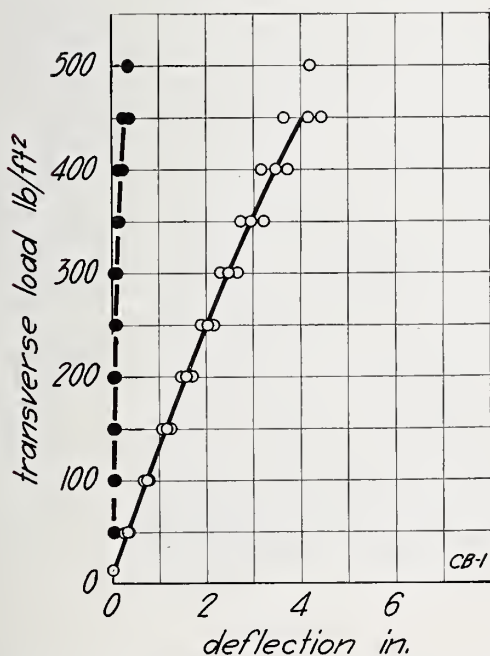
FIGURE 10.—Transverse load on wall CB, load applied to inside face.

Load-deflection (open circles) and load-set (solid circles) results for specimens CB-T1, T2, and T3 on the span 7 ft 6 in.

In specimen *T1* at a load of 400 lb/ft² two planks ruptured at or between the loading rollers, and at the maximum load the specimen failed by rupture of two more planks between the loading rollers. Specimen *T2* failed at maximum load by rupture of all the planks at a loading roller. In specimen *T3* at a load of 450 lb/ft² one plank ruptured between the loading rollers and at the maximum load the specimen failed by rupture near midspan of three more planks. The plywood wallboard of the specimens was undamaged, but on specimen *T1* it had separated from the planks.

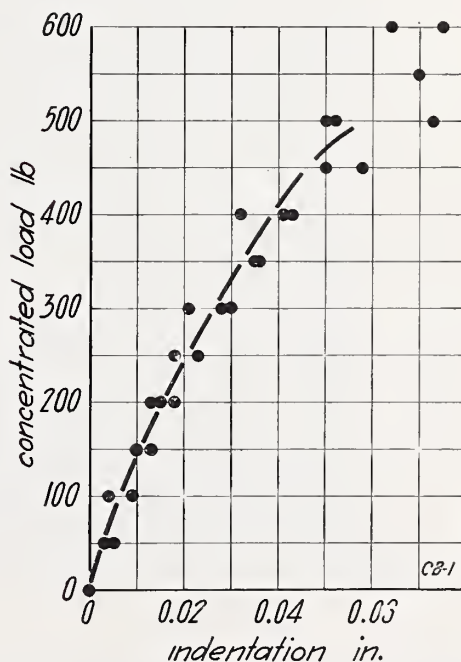
FIGURE 12.—Concentrated load on wall CB, load applied to inside face.

Load-indentation results for specimens CB-P1, P2, and P3.

The results of the concentrated-load tests are shown in table 4 and in figure 12 for wall specimens *CB-P1*, *P2*, and *P3*, loaded on the inside face, and in figure 13 for wall specimens *CB-P4*, *P5*, and *P6*, loaded on the outside face.

The concentrated loads were applied to the inside face of specimens *P1*, *P2*, and *P3* on the plywood wallboard over the cavity between the wallboard and a projecting plank, about 2

ft from one end. Each of the specimens failed by punching of the disk through the wallboard.

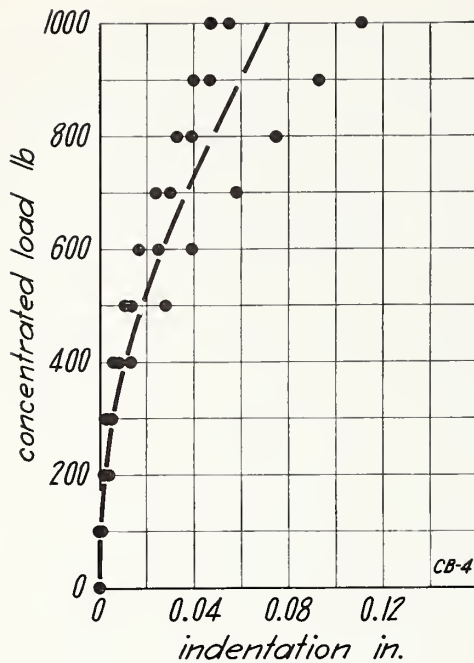
FIGURE 13.—Concentrated load on wall CB, load applied to outside face.

Load-indentation results for specimens CB-P4, P5, and P6.

The concentrated loads were applied to the outside face of specimens *P4*, *P5*, and *P6* on a plank, about $2\frac{1}{2}$ ft from the top end. The indentations after a load of 1,000 lb had been applied were 0.047, 0.111, and 0.055 in. in specimens *P4*, *P5*, and *P6*, respectively, and no other effect was observed.

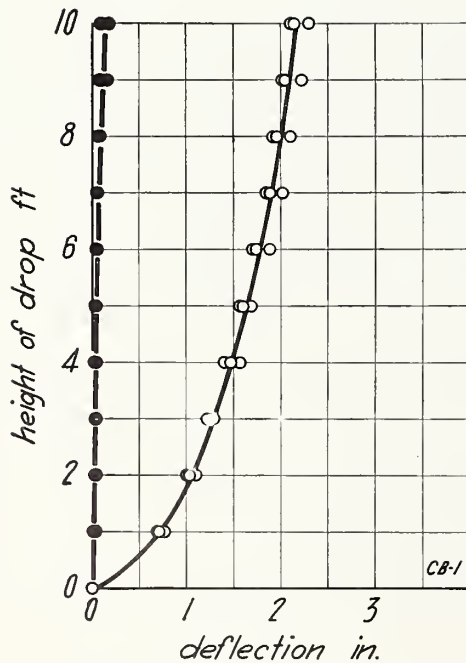
FIGURE 14.—Impact load on wall CB, load applied to inside face.

Height of drop-deflection (open circles) and height of drop-set (solid circles) results for specimens CB-I1, I2, and I3 on the span 7 ft 6 in.

The results of the impact test are shown in table 4 and in figure 14 for wall specimens

joint between the center planks where the sandbag struck. In addition, in specimen *I2* at a drop of 7.5 ft the floor plate split at the edge of the specimen and the filler strip along the edge separated from the plank. The sets after a drop of 10 ft were 0.177, 0.096, and 0.114 in. for specimens *I1*, *I2*, and *I3*, respectively, and no other effect was observed.

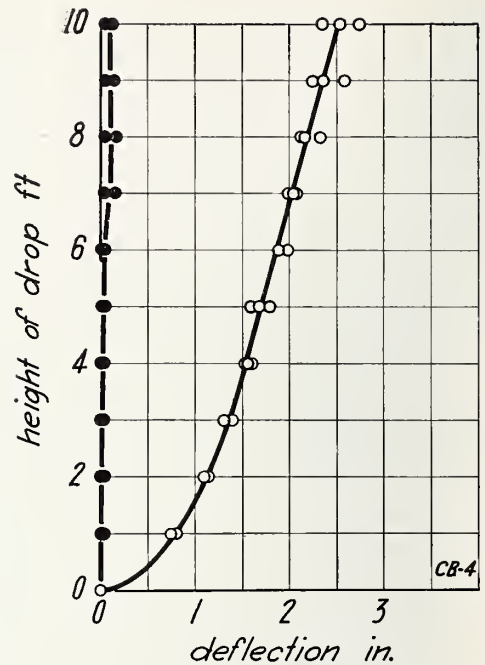
FIGURE 15.—Impact load on wall CB, load applied to outside face.

Height of drop-deflection (open circles) and height of drop-set (solid circles) results for specimens CB-I4, I5, and I6 on the span 7 ft 6 in.

CB-I1, *I2*, and *I3*, loaded on the inside face, and in figure 15 for wall specimens *CB-I4*, *I5*, and *I6*, loaded on the outside face.

The impact loads were applied to the center of the outside face of specimens *I4*, *I5*, and *I6*, the sandbag striking the planks. In specimen *I4* at a drop of 4.5 ft there was noticeable opening of the joint between the two center planks

near midspan, and at a drop of 7 ft the planks separated at the matched joint, causing failure of the outside face. At a drop of 9 ft the battens started to separate from the plywood wallboard by pulling the nails from the planks at one edge of the specimen. At the 10-ft drop the floor plate and top plate separated from the planks, and the floor plate split. The set after a drop of 10 ft was 0.132 in. In specimen I5 at a drop of 5.5 ft the top plate split, and at the 6.5-ft drop there was noticeable displacement between the two center planks at midspan. The set after a drop of 10 ft was 0.042 in. In specimen I6 at a drop of 7 ft the joint between the two center planks opened at midspan, causing failure of the outside face. At a drop of 8.5 ft the edge filler strip separated from the plank, and at a drop of 9.5 ft the edge batten also separated. The set after a drop of 10 ft was 0.124 in.

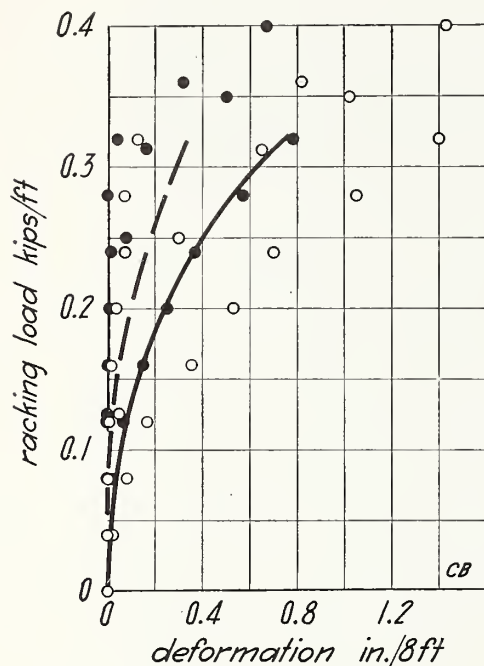
FIGURE 17.—Racking load on wall *CB*.

Load-deformation (open circles) and load-set (solid circles) results for specimens *CB-R1*, *R2*, and *R3*. The loads are in kips per foot of actual width of specimen.

Wall specimen CB-R2 under racking load is shown in figure 16. The results for wall specimens CB-R1, R2, and R3 are shown in table 4 and in figure 17.

specimen *R1* at a load of 0.312 kip/ft the plywood wallboard separated from the loaded edge of the specimen, pulling the nails from the plank and the filler strip. There was notice-

wallboard; and at loads of 0.320 and 0.360 kip/ft respectively, the wallboard separated from the loaded edge of the specimens. At the maximum loads each of the specimens failed by continued slipping of the planks at the joints. The wallboard had pulled the nails from the planks, and the top plate had bowed upward at midwidth. Also the floor plate of specimen *R3* had separated from the planks, leaving the nails in the planks.

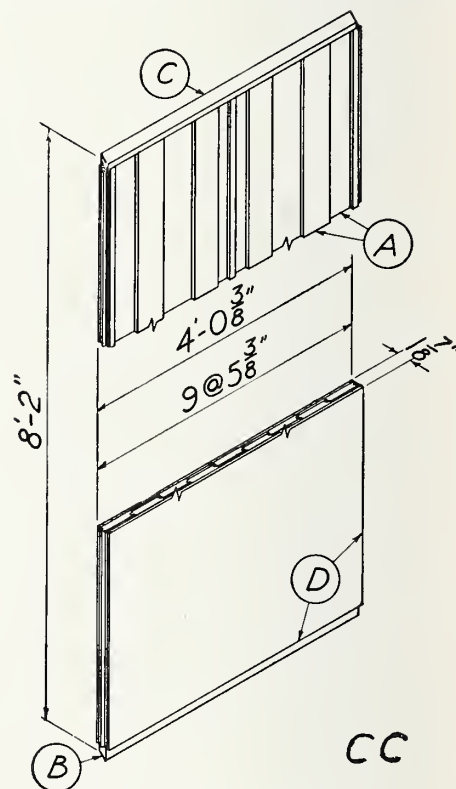
FIGURE 18.—Partition specimen *CC*.

A, planks; *B*, floor plate; *C*, top plate; *D*, plywood wallboard.

The plank partition specimens shown in figure 18, were 8 ft 2 in. high, 4 ft $\frac{3}{8}$ in. wide, and $1\frac{1}{8}$ in. thick. Each specimen consisted of nine tongue-and-grooved planks, *A*, so assembled that alternate planks projected $\frac{1}{4}$ in. The planks were fastened to a floor plate, *B*, and a top plate, *C*, by splines. The faces consisted of plywood wallboard, *D*. The floor plate, top plate, and edges of the specimens were covered

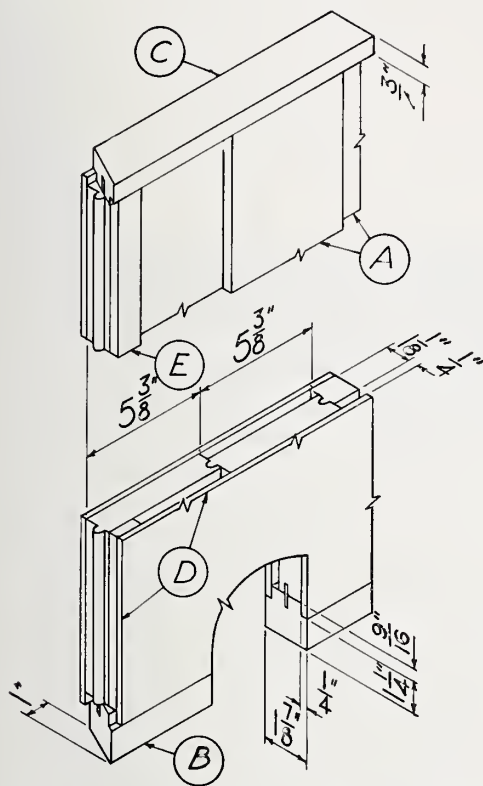
FIGURE 19.—Details of partition specimen CC.

A, planks; B, floor plate; C, top plate; D, plywood wallboard; E, filler strip.

Planks.—The planks, *A*, were spruce, $1\frac{1}{8}$ by $5\frac{3}{8}$ in., 7 ft $10\frac{15}{16}$ in. long. The edges of each plank were tongued and grooved on a line $\frac{1}{8}$ in. from midthickness, and the planks were assem-

bled as shown in figure 19. After assembly the planks were held by box strapping fastened to both faces. The strapping consisted of two horizontal strips, one near the bottom, the other near the top, and one strip applied diagonally

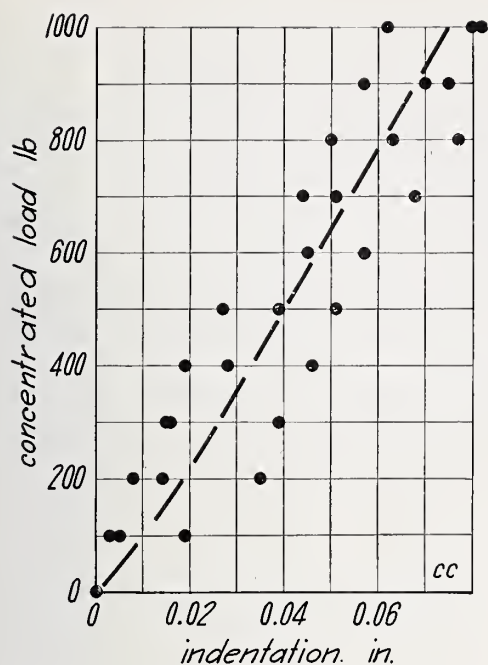
FIGURE 21.—Concentrated load on partition CC.
Load-indentation results for specimens CC-P1, P2, and P3.

Partition specimen CC-P1 under concentrated load is shown in figure 20. The results for partition specimens CC-P1, P2 and P3 are shown in table 5 and in figure 21.

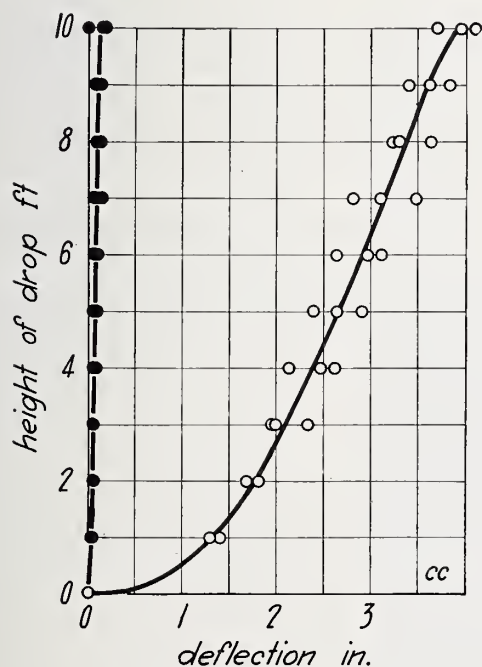
FIGURE 22.—Impact load on partition CC.
Height of drop-deflection (open circles) and height of drop-set (solid circles) results for specimens CC-I1, I2, and I3 on the span 7 ft 6 in.

The results of the impact tests for partition specimens *CC-I1*, *I2*, and *I3* are shown in table 5 and in figure 22.

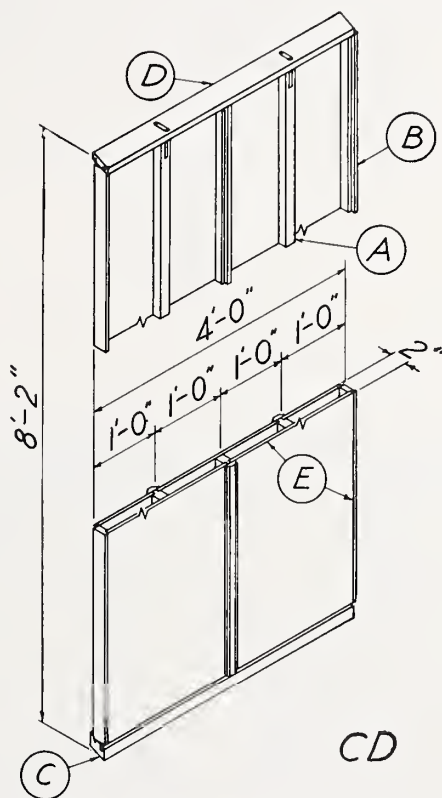
FIGURE 23.—Partition specimen CD.

A, full-sized stud; *B*, half-sized stud; *C*, floor plate; *D*, top plate; *E*, plywood wallboard.

The frame partition specimens, shown in figure 23, were 8 ft 2 in. high, 4 ft 0 in. wide, and 2 in. thick. Each specimen consisted of a wood frame to which the faces were fastened. The frame consisted of three full-sized studs, *A*, and two half-sized studs, *B*, fastened to a floor plate, *C*, and a top plate, *D*. The faces consisted of plywood wallboard, *E*. The floor plate, top plate, and edges of the specimen were covered with one coat of lead-and-oil paint. The faces were covered with one coat of shellac varnish. Both paint and shellac were applied with a brush.

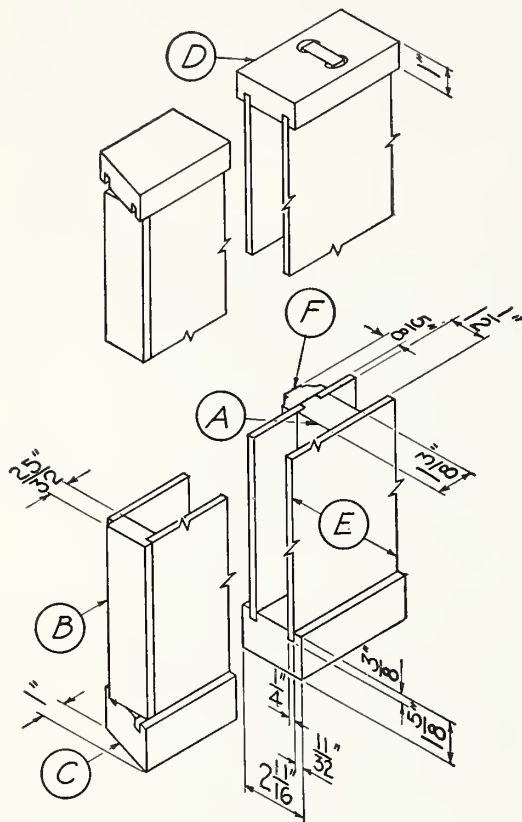
FIGURE 24.—Details of partition specimen CD.

A, full-sized stud; B, half-sized stud; C, floor plate; D, top plate; E, plywood wallboard; F, batten.

Studs.—The full-sized studs, *A*, were spruce, $1\frac{3}{8}$ by $1\frac{3}{4}$ in., 7 ft $11\frac{3}{8}$ in. long, with $\frac{3}{8}$ - by $\frac{1}{4}$ -in. recesses in two edges, as shown in figure 24. They were spaced 1 ft 0 in. on centers.

Top plate.—The top plate, *D*, was spruce, 1 by $2\frac{11}{16}$ in., 4 ft 1 in. long, with two grooves on

the lower surface. The ends were parallel and beveled 1 in. The top plate was fastened to the center stud by one 6d common nail driven through the top plate into the stud, and to the two outer full-sized studs by a piece of box

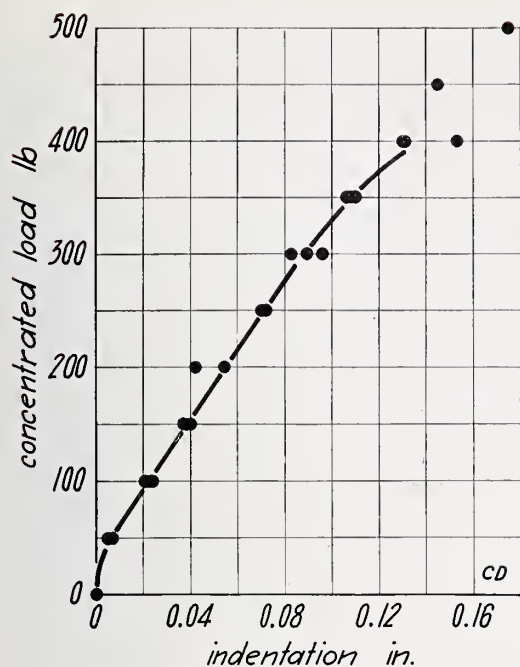
FIGURE 25.—Concentrated load on partition *CD*.
Load-indentation results for specimens *CD-P1*, *P2*, and *P3*.

The results of the concentrated-load tests on partition specimens *CD-P1*, *P2*, and *P3* are shown in table 6 and in figure 25.

The concentrated loads were applied to the plywood wallboard midway between full-sized studs and from 2 to $2\frac{1}{2}$ ft from one end of the specimen. At the maximum load each of the

specimens failed by punching of the disk through the wallboard.

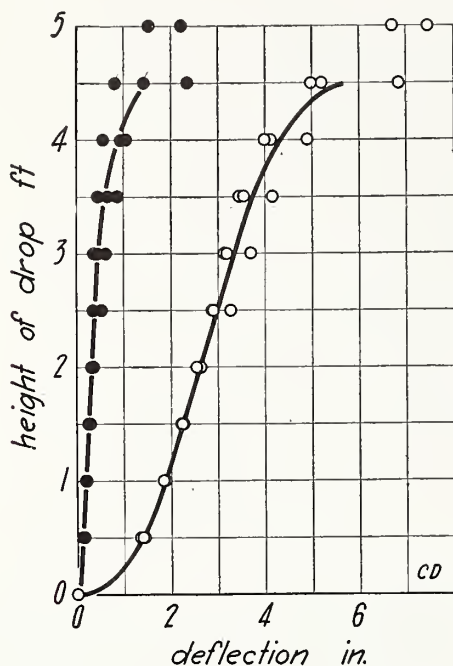
FIGURE 27.—Impact load on partition CD.

Height of drop-deflection (open circles) and height of drop-set (solid circles) results for specimens CD-II, I2, and I3 on the span 7 ft 6 in.

Partition specimen *CD-I3* during the impact test is shown in figure 26. The results for partition specimens *CD-I1*, *I2*, and *I3* are shown in table 6 and in figure 27.

and the top plate split. At the maximum drop the remaining studs ruptured and the specimen broke in two along the center stud. On specimens *I2* and *I3* at drops of 4 ft the face not struck failed by opening of the joint under one batten, and at drops of 4.5 ft the face struck failed by opening of the joint under the center batten. In specimen *I2* at a drop of 5 ft the center stud ruptured, at a drop of 5.5 ft one outer full-sized stud ruptured, and at the maximum drop the specimen broke in two and the top plate separated from the studs. In specimen *I3* at a drop of 5.5 ft the center stud ruptured, at a drop of 6 ft the two outer full-sized studs ruptured, and at the maximum drop the specimen broke in two.

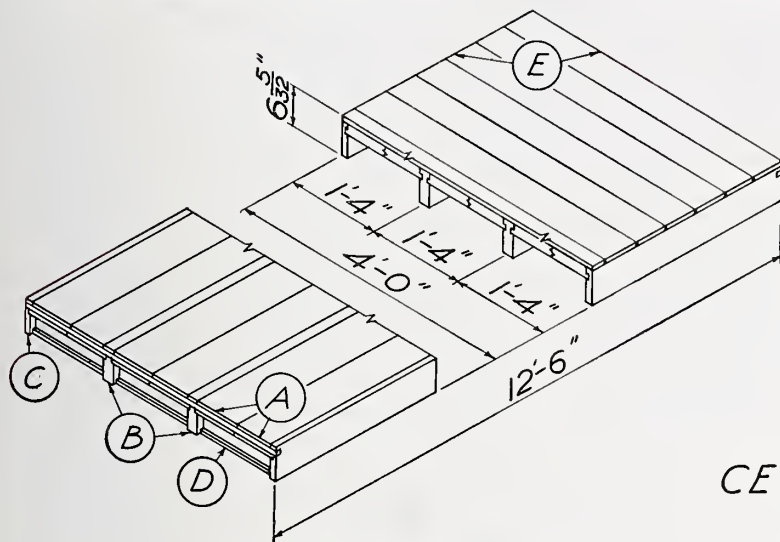
FIGURE 28.—Floor specimen CE.

A, planks; B, full-sized joists; C, half-sized joists; D, end members; E, flooring.

The floor specimens, shown in figure 28, were 12 ft 6 in. long, 4 ft 0 in. wide, and 6 $\frac{5}{32}$ in. deep. Each specimen consisted of six specially edge-

The half-sized joists, *C*, were spruce, $\frac{25}{32}$ by 5 $\frac{3}{8}$ in. (nominal 1 by 6 in.), 12 ft 6 in. long, grooved $\frac{7}{8}$ by $\frac{3}{8}$ in. on one side, $\frac{7}{8}$ in. below the upper edge. The projecting edge of the outer plank fitted into the groove in the half-sized joist and was fastened by 6d box nails, 6d common nails, 1 $\frac{1}{2}$ -in. plasterboard nails, or 6d shingle nails. The nails were spaced from 1 to 2 ft and were driven through the half-sized joists into the plank. A strip of perforated hanger iron was fastened along the ends of the planks and extended around the corners of the specimen about 1 in., as shown in figure 28. It was fastened to the half-sized joists and to each plank by two 1 $\frac{1}{2}$ -in. plasterboard nails.

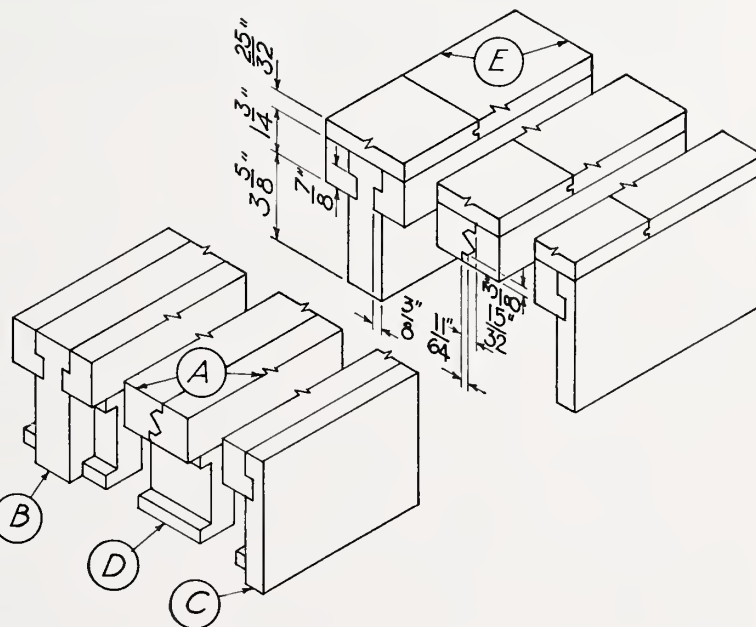
FIGURE 29.—Details of floor specimen CE.

A, planks; B, full-sized joist; C, half-sized joist; D, end member; E, flooring.

Planks.—The planks, *A*, were spruce, 1 $\frac{3}{4}$ by 7 $\frac{1}{16}$ in. (nominal 2 by 8 in.), 12 ft 6 in. long. One edge of the plank was recessed $\frac{7}{8}$ by $\frac{3}{8}$ in., and the opposite edge was matched, as shown in figure 29.

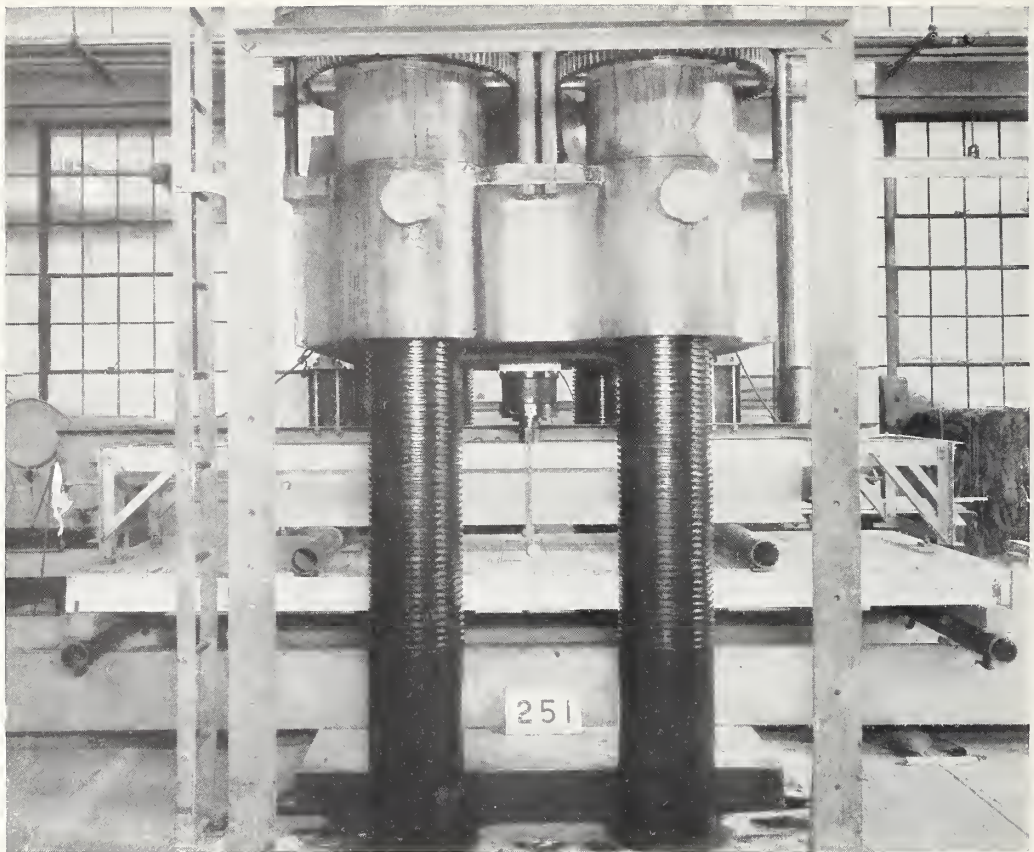
FIGURE 30.—Floor specimen CE-T2 under transverse load.

Floor specimen CE-T2 under transverse load is shown in figure 30. The results for floor specimens CE-T1, T2, and T3 are shown in table 7 and in figure 31.

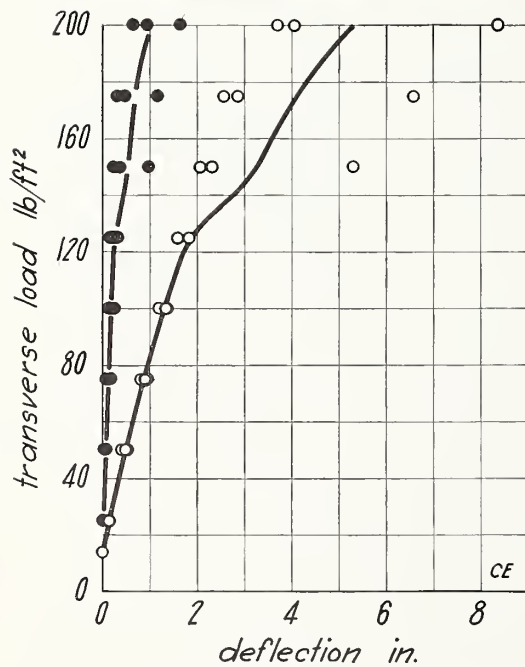
FIGURE 31.—Transverse load on floor CE.

Load-deflection (open circles) and load-set (solid circles) results for specimen CE-T1, T2, and T3 on the span 12 ft 0 in.

In specimen T1 at a load of 177 lb/ft² the half-sized joists split at middepth both between the loading rollers and from one end to midspan. At a load of 211 lb/ft² the two inner joists ruptured at knots near midspan, and at the maximum load they ruptured completely. As the deflection increased all the planks ruptured at midspan. In specimen T2 at a load of

135 lb/ft² both half-sized joists split at mid-depth along the entire length of the specimen. At a load of 150 lb/ft² one full-sized joist ruptured under both loading rollers, and at 175 lb/ft² the other full-sized joist split the entire length of the specimen along the groove in the joist. At the maximum load the full-sized joist split and four planks ruptured between the loading rollers. In specimen T3 at a load of 175 lb/ft² the half-sized joists ruptured at mid-span, at a load of 200 lb/ft² both inner joists ruptured at or between the loading rollers, and at the maximum load two planks ruptured at or between the loading rollers. In all specimens the flooring was undamaged, though in specimen T1 it had separated noticeably from the planks.

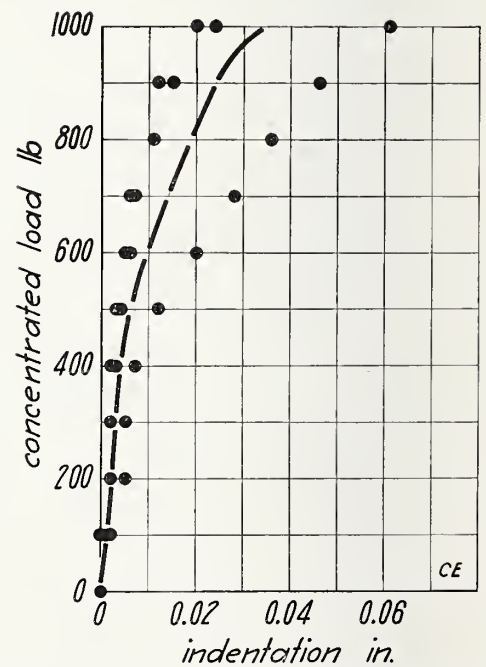
FIGURE 32.—Concentrated load on floor CE.

Load-indentation results for specimens CE-P1, P2, and P3.

The results for floor specimens CE-P1, P2, and P3 under concentrated load are shown in table 7 and in figure 32.

The concentrated loads were applied between full-sized joists at the corner of an end joint in the flooring either 6 ft or 2 ft from one end of the specimen. The indentations after a load of 1,000 lb had been applied were 0.024, 0.020, and 0.061 in. for specimens *P*₁, *P*₂, and *P*₃, respectively, and no other effect was observed.

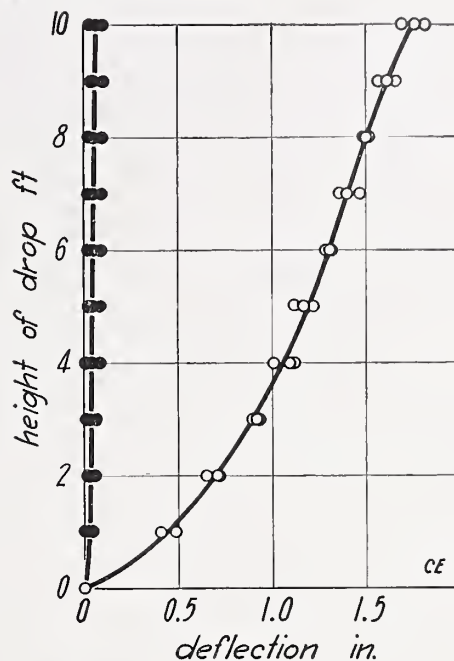
FIGURE 33.—*Impact load on floor CE.*

Height of drop-deflection (open circles) and height of drop-set (solid circles) results for specimens *CE-I*₁, *I*₂, and *I*₃ on the span 12 ft 0 in.

The results for floor specimens *CE-I*₁, *I*₂, and *I*₃ under impact load are shown in table 7 and in figure 33.

The impact loads were applied to the upper face, the sandbag striking the flooring between the full-sized joists. The sets after a drop of 10 ft were 0.034, 0.102, and 0.065 in. for specimens *I*₁, *I*₂, and *I*₃ respectively, and no other effect was observed.
